Vehicle mismatch: injury patterns and severity

S. Acierno^{a,b,*}, R. Kaufman^c, F.P. Rivara^{c,d}, D.C. Grossman^{a,c,d,e}, C. Mock^{b,c,d}

Abstract

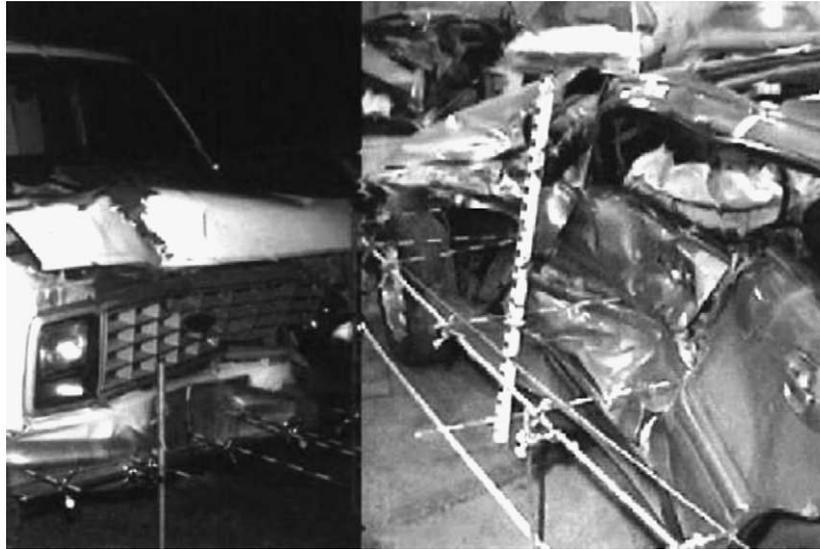
3.1.1.1. Side impact Case 4. The case occupant is a 36-year-old female who was the restrained driver of the case vehicle (1993 full size four-door sedan) involved in a left side impact with a large van with a PDOF of 280° degrees and a ΔV of 26 mph. The majority of the direct damage was into the case vehicle's driver door, extending forward to above the left front tire. The base of the van's bumper frame was measured at 43 cm above the ground with the front hood transition point at almost 1.2 m above the ground. The direct damage on the case vehicle began at the middle of the driver's door and extended almost to the roof side rail. The direct damage on the van's front hood edge showed the outline of the left side roof A-pillar of the case vehicle and next to this was a slight rounded dent. This dent was possibly an occupant contact and matched the seated height and location of the case occupant's head (Fig. 1). Lateral intrusion was measured at 28 cm at both the middle and upper driver door panel and was due to the frame height of the van. Deformation and scuffing were

found on the interior door panel and armrest, matching the occupant's left pelvis and chest.

Fig. 1. External damage photographs from side impact Case 4 showing impacting vehicle (left) and target vehicle (right). Note the imprint of the car's A-pillar on the hood of the van. A dent can be seen from contact of the subjects head with the hood of the van, just to the right of the A-pillar mark.

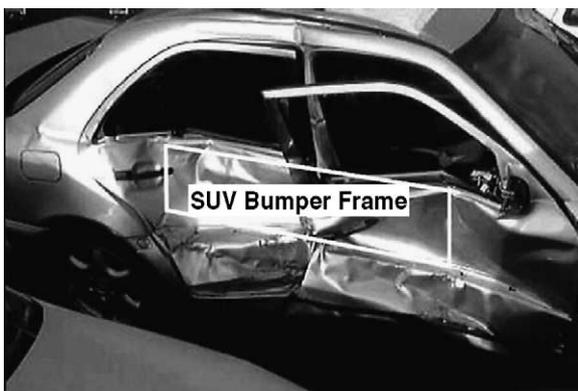
B-pillar intrusion. The door panel intrusion appeared to contact the lower right chest, but the side airbag protected the upper chest by covering the upper door panel (Fig. 3). This side airbag, which extended vertically 27 cm above the armrest, covering the lower side window area, also prevented the head from contacting with the side interior and possibly even from striking the front of the SUV.

Fig. 2. Side impact Case 11 external damage demonstrating upper door intrusion. The box indicates the contact area of the SUV bumper frame.

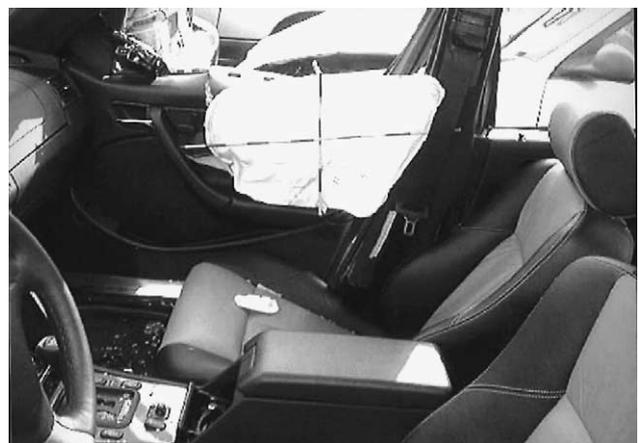
Fig. 3. Side impact Case 11 internal damage demonstrating rearward position of the seat with airbag deployment protecting the head and upper chest.

were not protected by the airbag due to the positioning of the seat with respect to the B-pillar.

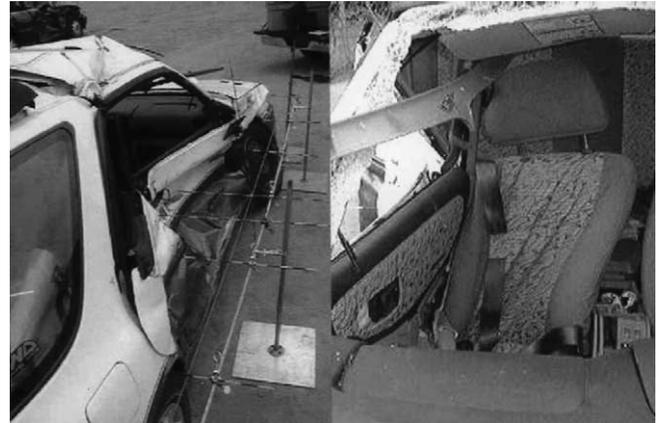
The greater LTV bumper frame height resulted in intrusion above the mid to lower door reinforcement designed to satisfy federal motor vehicle safety standard (FMVSS) 214. The LTV frames contacted the PV frames in weaker, non-reinforced areas, leading to maximal intrusions into the head and upper thorax of the occupants (Fig. 5). In three cases, the occupants head actually contacted with the hood of the LTV. In the second case discussed, the observed pattern of head and upper thoracic injury may have been prevented by the side airbag, demonstrating how airbags may help ameliorate this problem. However, this subject still sustained serious injuries to her abdomen and pelvis, which

Fig. 5. Side impact collision above reinforcement with exterior and interior views demonstrating contact with upper chest and head.

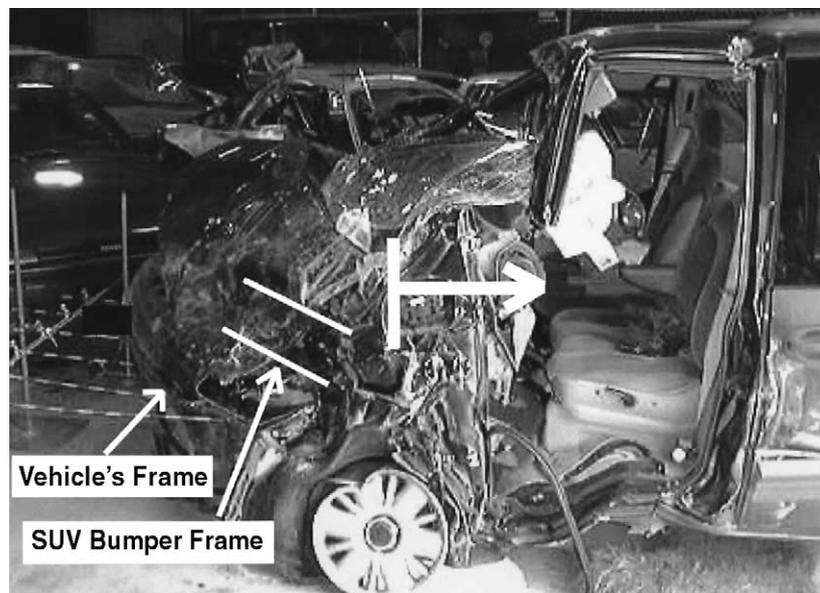
o'clock and ΔV was 27 mph. Due to the mismatch in vehicle heights the SUV's bumper frame impacted above the case vehicle's bumper frame. Thus, the direct damage on the case vehicle occurred at the weaker areas of the grill and hood extending to the base of the windshield, causing significant longitudinal intrusion into the passenger compartment (Fig. 6). The instrument panel and knee bolster system intruded longitudinally 45 cm along with the toe pan at 42 cm. Interior contact evidence showed that both of the driver's knees had pocketed into the knee bolster system during the frontal force of the crash. The severe longitudinal intrusion minimized the occupant space, increased the axial loads on the lower extremities and forced the driver rearward into the fixed seatback. The seatbelt and frontal airbag deployment

Fig. 6. Front impact Case 12 external damage. Note the extensive deformation above the bumper frame, as well as the intrusion of the A-pillar and instrument panel (original position indicated by bar with arrow) into the passenger compartment.

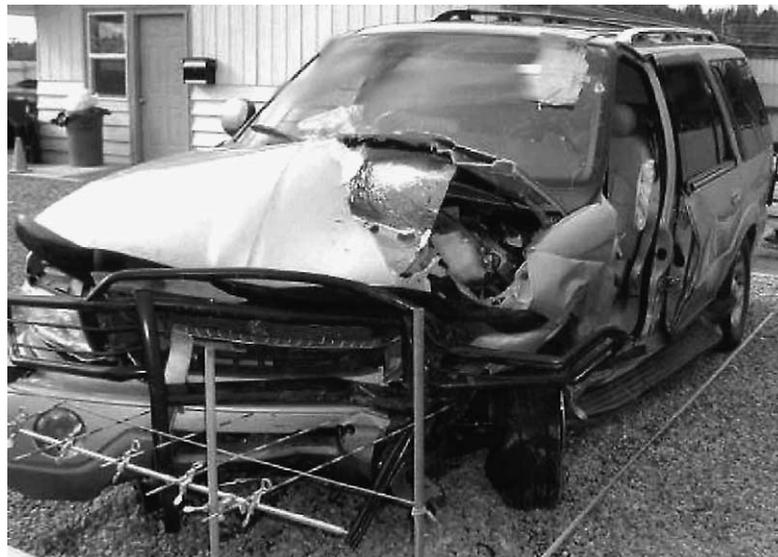
This crash involved a 50-year-old female who was the restrained driver of the case vehicle, a 2000 large SUV. A 1997 compact vehicle crossed the centerline causing a frontal offset collision with the case vehicle. The mismatch in the bumper frame heights caused the case vehicle to override the compact vehicle's bumper frame creating severe longitudinal compartment intrusion and fatally injuring the other driver. The bumper frame height of the compact vehicle impacted below the case vehicle's bumper frame striking only the front left tire and axle (Fig. 8). This forced the front left tire rearward into the floor board and toe pan exposing it at the foot controls of the case driver position (Fig. 9). The intrusion was measured at 55 cm. There was no pre-impact braking and both feet were directly impacted by this severe front tire intrusion. Extrication required 20 min.

Fig. 8. Front impact LTV Case 4 external damage. Notice the underriding damage pushing the left front tire backward.

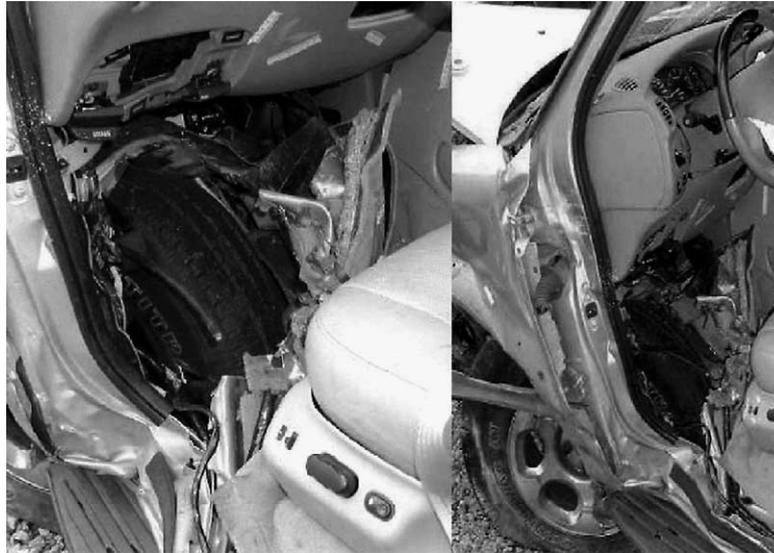
Fig. 9. Front Impact LTV Case 4 internal damage (right) with close up view (left). The left front tire can be seen intruding through the toe pan causing severe foot and ankle fractures.

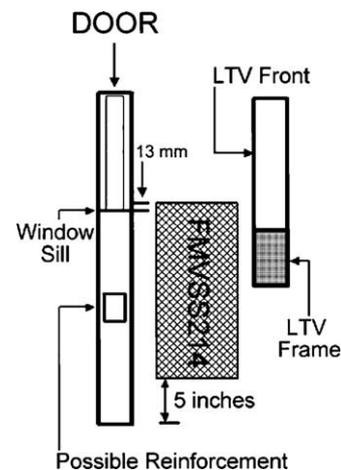
Fig. 11. FMVSS 214 crash test barrier compared to LTV front end. The FMVSS 214 barrier begins 127 mm above the bottom of the door and ends no more than 13 mm above the window sill. The LTV front end is considerably higher, striking above the reinforcement that would pass FMVSS 214.

(Fig. 11). The IIHS is currently using a barrier 30 cm higher than the NHTSA barrier to simulate LTV impacts. Revision of FMVSS 214 to require better performance when vehicles are struck by higher barriers may help minimize injuries from side impact mismatch collisions.
